D'APPOLONIA CONSULTING ENGINEERS INC PITTSBURGH PA  
NATIONAL DAM INSPECTION PROGRAM. RACCOON CREEK STATE PARK DAM (U)  
JUN 79 L D ANDERSEN

PHASE I REPORT  
NATIONAL DAM INSPECTION PROGRAM

NAME OF DAM: Raccoon Creek State Park Dam  
STATE LOCATED: Pennsylvania  
COUNTY LOCATED: Beaver County  
STREAM: Traverse Creek, a tributary of Raccoon Creek  
SIZE CLASSIFICATION: Intermediate  
HAZARD CLASSIFICATION: High  
DATE OF INSPECTION: December 13, 1978 and April 16, 1979

PHASE I REPORT  
NATIONAL DAM INSPECTION PROGRAM  
RACCOON CREEK STATE PARK DAM  
NDI I.D. NO. PA-262  
DER I.D. NO. 4-34

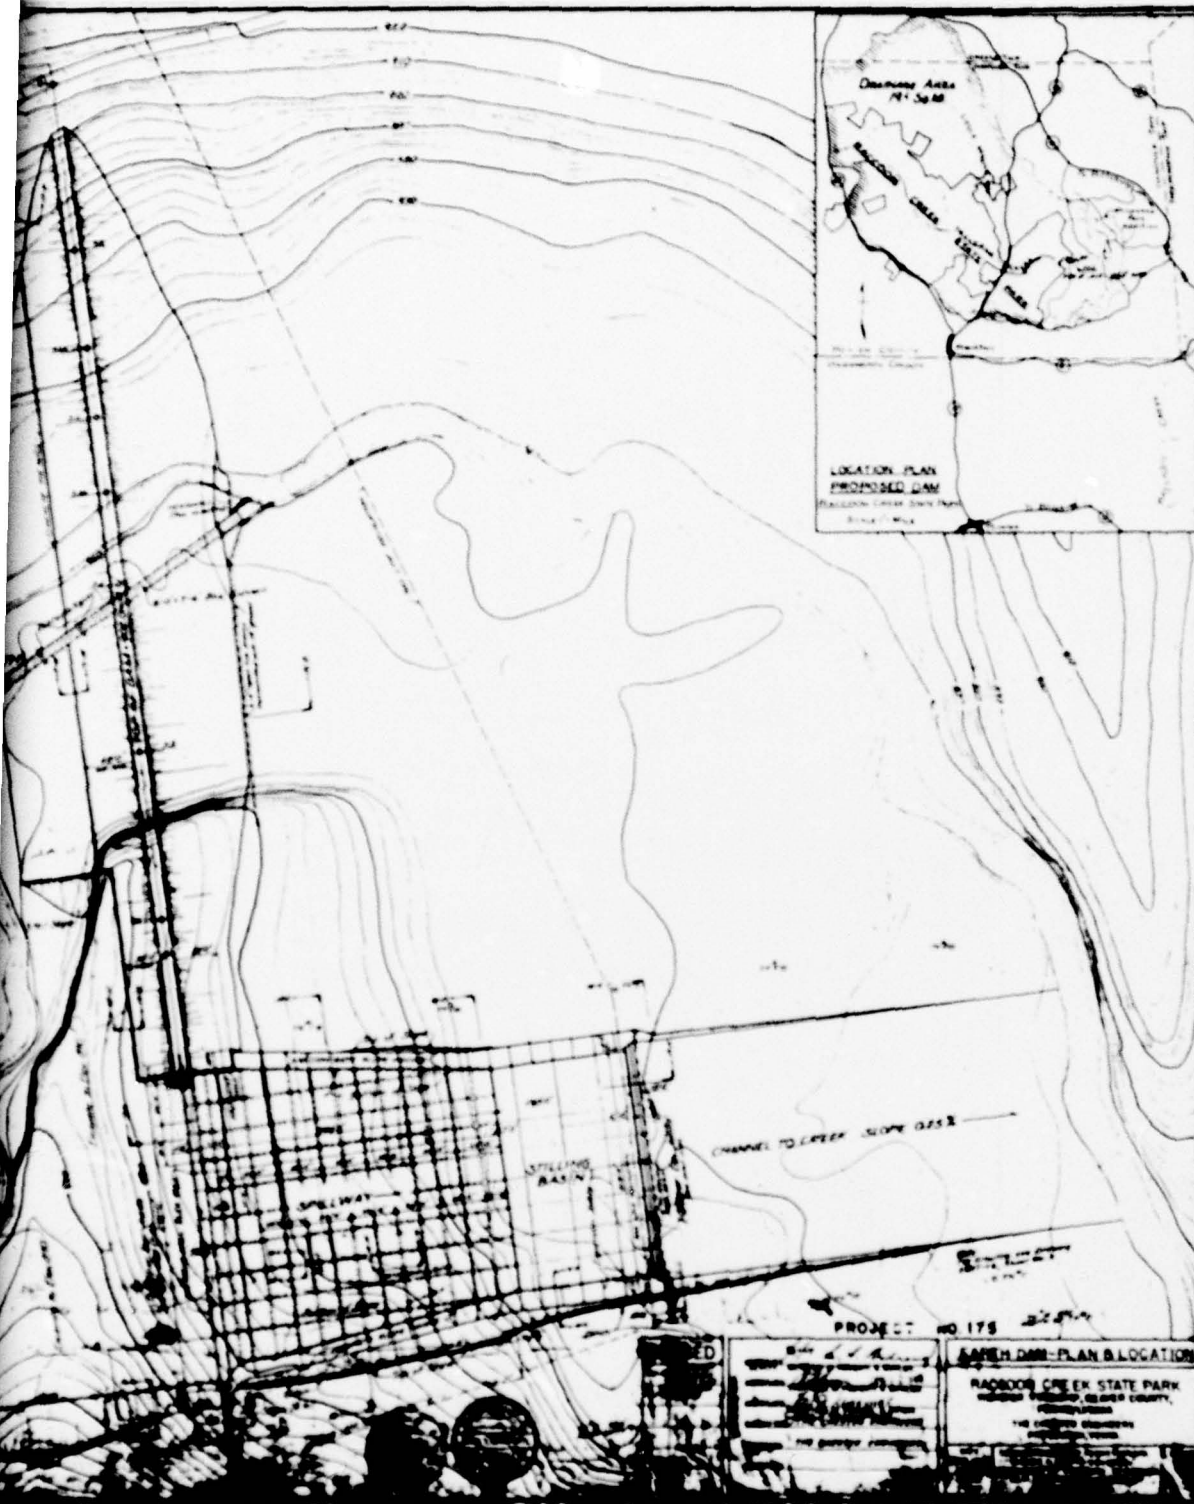
PLATE 3

- c. As shown in Plate 3, at least 12 borings were drilled for subsurface investigation. As illustrated in Plate 2, the typical subsurface profile consists of approximately 10 to 30 feet of overburden underlain by shale.

(2) Appurtenant Structures. The appurtenant structures of the dam consist of a combined primary and emergency spillway and an outlet works (Plate 3). The spillway structures include a 40-foot-long concrete-lined approach channel, a 300-foot-long ogee concrete overflow section, a trapezoidal discharge channel, and a stilling basin at the toe level of the dam. The bottom of the approach channel as designed is at Elevation 1885, leaving a 9-foot approach depth at normal pool level. The ogee overflow crest is at Elevation 1894. The trapezoidal concrete discharge channel is approximately 250 feet long and converges uniformly from a width of 300 feet at the overflow section to 213 feet at the downstream end. A 213-foot-wide, 130-foot-long stilling basin is also trapezoidal in cross section. The minimum depth of water in the stilling basin is maintained at 4 feet by the sill at the downstream end. The slab sections of the spillway discharge channel and the stilling basin are 9 inches thick and underlain by a one-foot gravel filter. The gravel filter drains into the spillway channel through 4-inch weepholes.

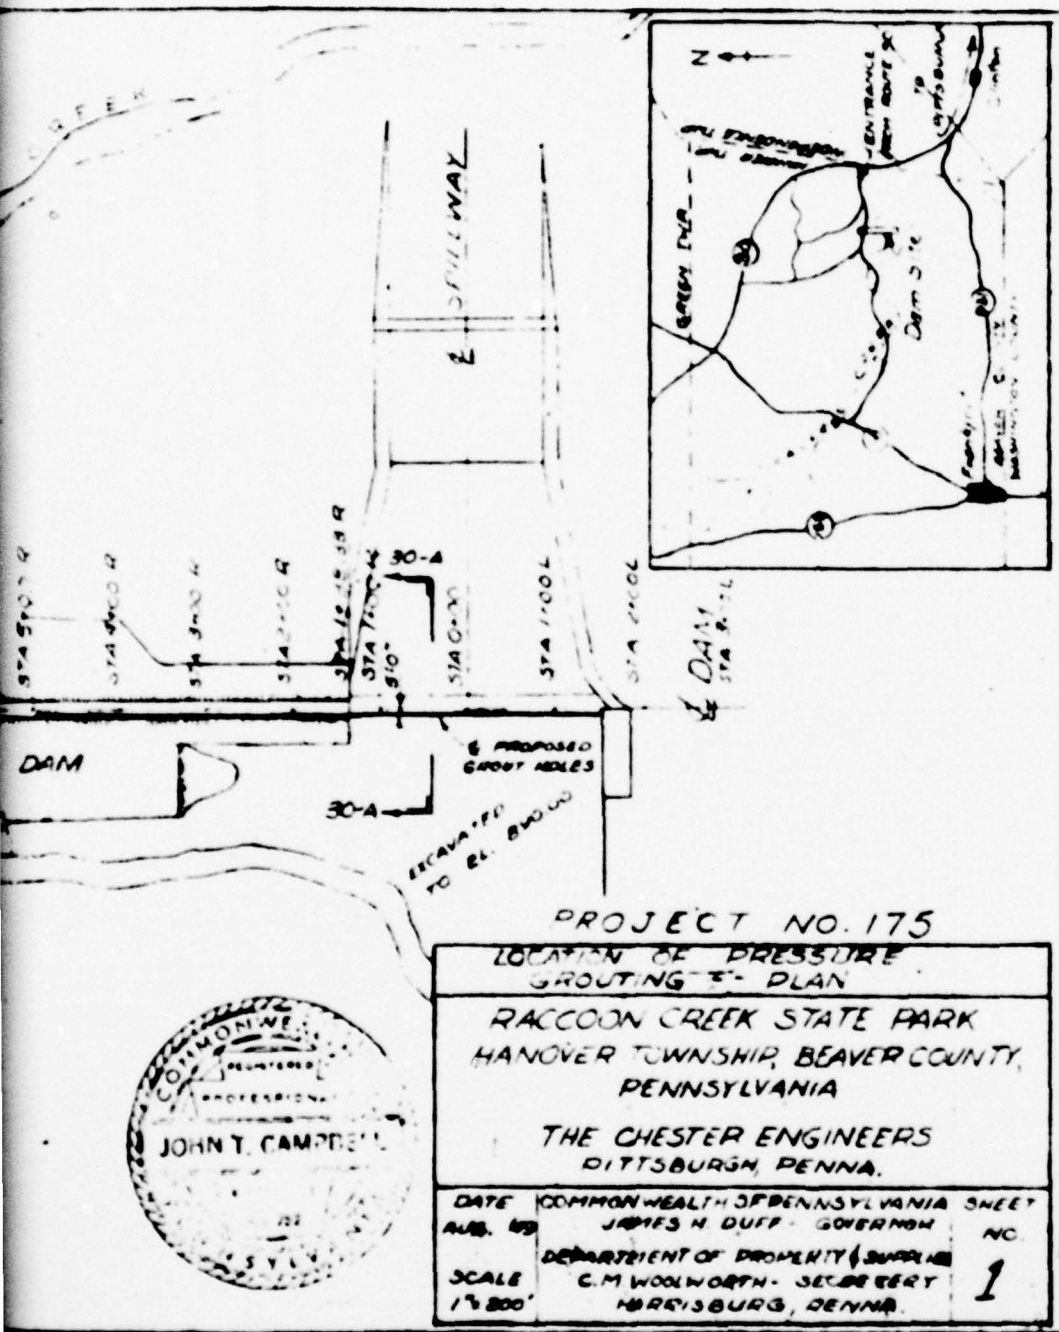
- d. The available information indicates that a 150-foot long section of the foundation on the left side of the original streambed was grouted through holes drilled at 5-foot centers extending to a depth of 25 feet below the base of the cutoff trench. Plates 5 and 6 illustrate the locations of grout holes through the spillway and the right side of the embankment, which was performed after the completion of the dam.

During the initial filling of the lake, seepage was observed along the toe of the dam near the right abutment when the pool level was within 10 feet of the spillway crest level. The quantity of seepage was estimated to be on the order of 70 gallons per minute. In 1949, a remedial grouting program was undertaken to control the seepage. Plates 5 and 6 illustrate the extent of the remedial grouting program. In the subsequent inspection reports, no reference was found to the seepage problem, indicating that the grouting program apparently effectively controlled the seepage through the embankment.
